# D.B. Wilson Phase II CCR Landfill

Disposal of Coal Combustion Residuals (CCR) from Electric  
Utilities Final Rule  
CCR Phase II Landfill 2020 Annual Inspection Report

Big Rivers Electric Corporation

January 8, 2021

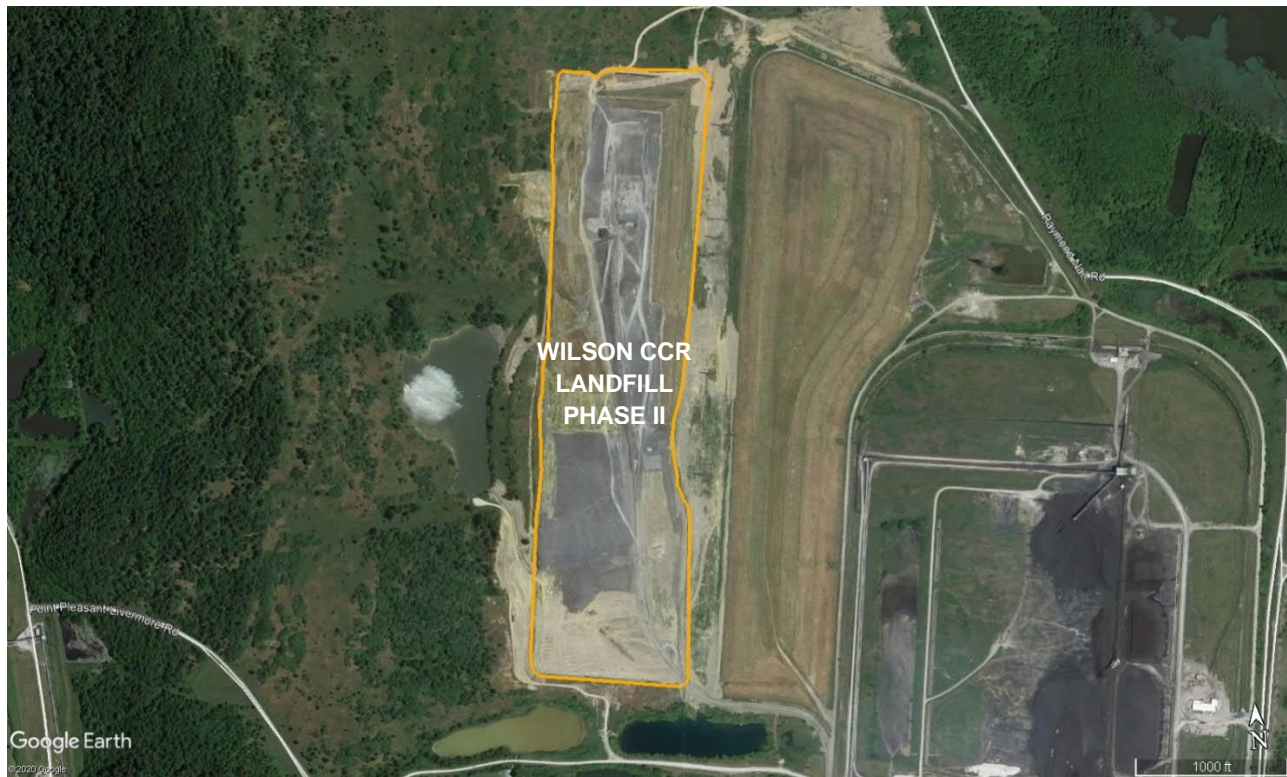
**Figure 1: D.B. Wilson Phase II CCR Landfill Aerial Photograph**

Changes to the landfill geometry since the 2019 annual inspection includes placement of additional CCR, protective cover soils and establishing vegetation on the landfill.
