**Big Rivers Electric Corporation
Disposal of Coal Combustion Residuals (CCR) from Electric Utilities Final Rule
CCR Landfill Annual Inspection Report**

Name: D.B. Wilson CCR Landfill
Operator: D.B. Wilson Generating Station
Address: 5663 State Route 85 West
Centertown, KY 42328

D.B. WILSON GENERATING STATION
CCR LANDFILL

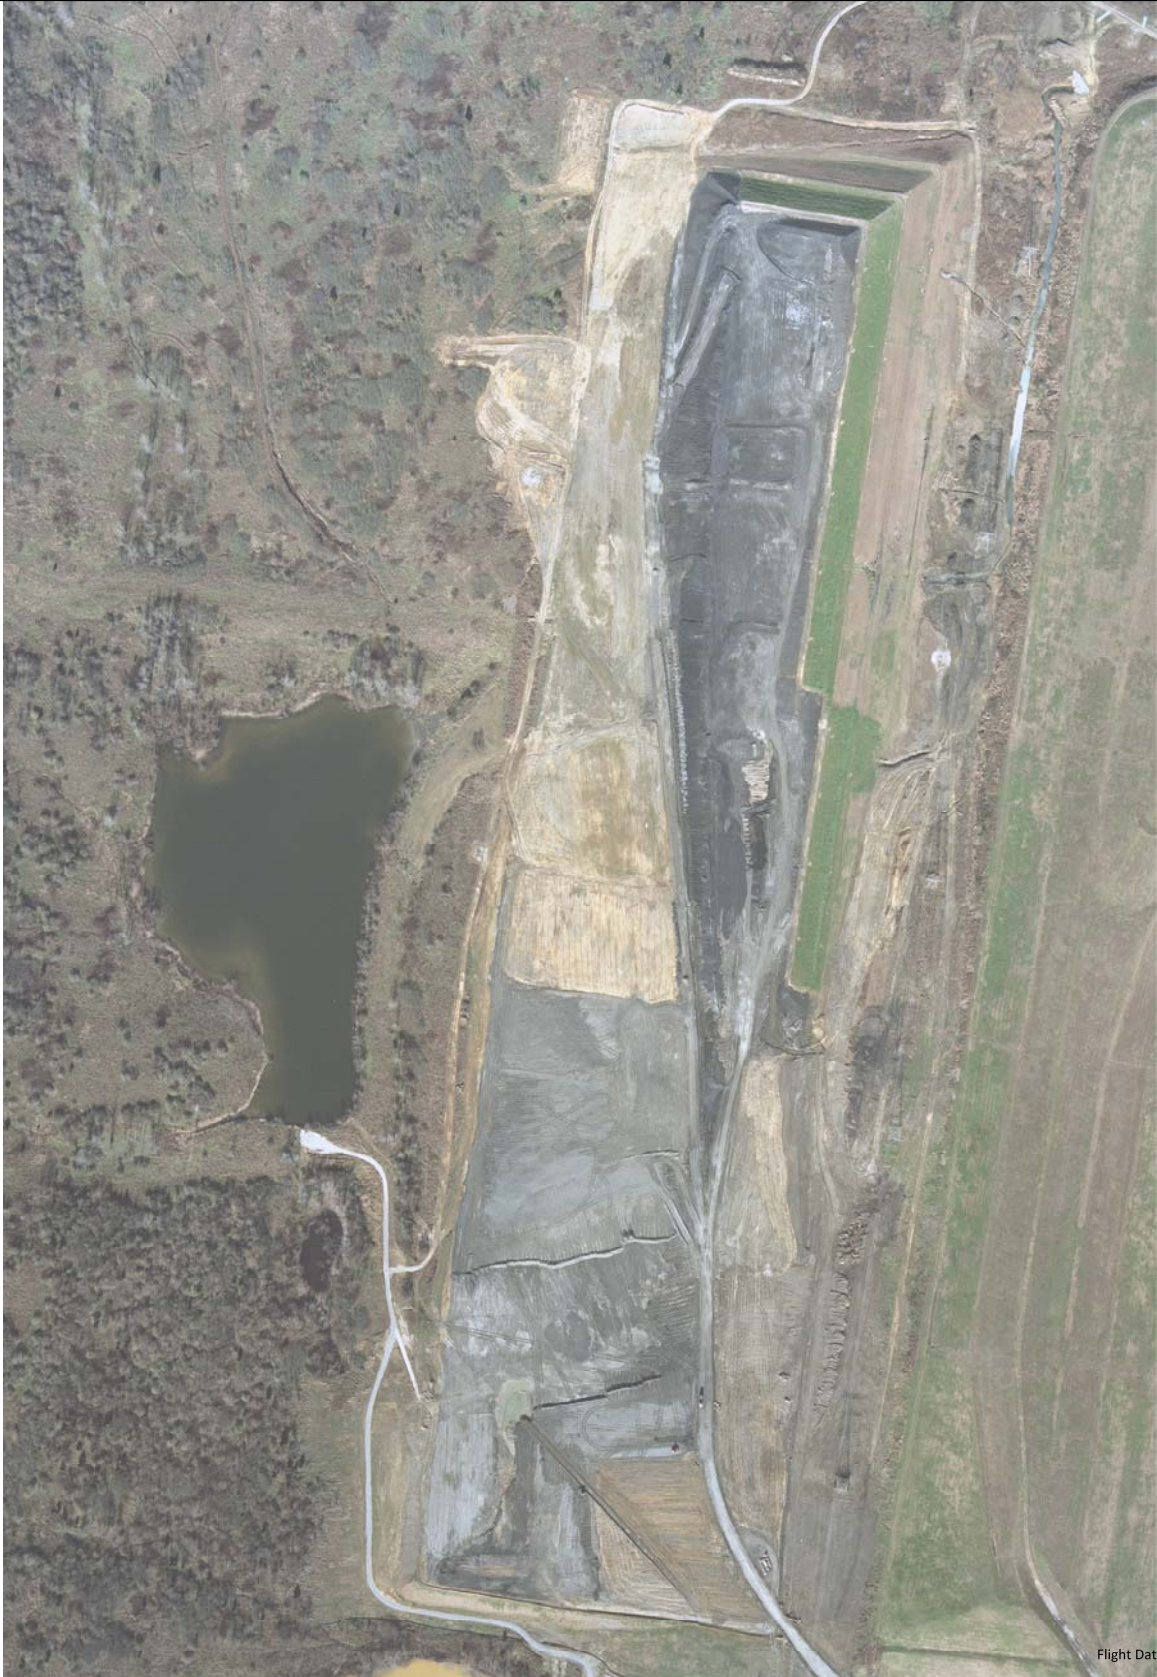
The inspection consisted of a visual assessment of the landfill and associated drainage control features (refer to Aerial Photo of the landfill and the Annual Inspection Checklist included with this report); and began on the north side of the landfill. The inspection noted that the slope and benches are fairly well vegetated with some erosion and bare areas with some benches retaining standing water creating very wet and soft ground conditions. Vegetation thickness and type varies across the north face with some thickly grassed areas and some areas supporting woody grasses and briars. Typical issues are animal tracking/burrows, longitudinal ruts from tractor and mower tires, spotty unvegetated/poorly vegetated areas and exposed shaley material across the slope. There is a deep ditch that has eroded from west to east diagonally across the north slope starting where the face ties into natural ground and flowing to the toe of the slope below the first bench. Vegetation is poor in this area supporting thick stands of sericea lespedeza and little grass.

The inspection moved to the east side of the landfill which is in various phases of soil cover and vegetation. Continuing around the corner from the north face, the northeast and central portions of the east face are mostly covered and vegetated with the upper benches having been most recently vegetated. The newly vegetated areas support good grass stands but rills are numerous where soil appears thin or contains rocks. The southern portion of the east face is in various stages of being covered and is not vegetated. Generally, the east side of the landfill is stable where covered and vegetated but there are significant areas of erosion and seepage on upper slopes and benches; along the lower slope and toe; and in areas having poor, sparse or no vegetation. There are several areas along the lower partial bench in the mid-section of the east slope where seepage from finished slopes has caused erosion extending downslope from the seeps. A failure between unfinished upper and mid-slope storm inlets has occurred in the central portion of the newly revegetated section of the east face. Drainage bypasses the upper inlet and eroded a path beneath the soil cover and exits at the downslope inlet. A wide area extending from the toe of the east face east towards the power line corridor is extremely wet with ponded water and little to no vegetation (phragmites is common in these areas). Sporadic small piles of rip rap are scattered along benches and at seep locations. Water is also standing in longitudinal depressions made by tractor and mower tires. Some areas of exposed CCR material are visible and erosion is occurring around some of the storm water inlets. Animal burrowing and tracking are visible sporadically across the east landfill face. Some areas of apparent soil slumping and saturated ground are evident along benches and toes of the east face. It should be noted that 2015 was one of the wettest years on record, complicating repair work.

The entire west side of the landfill is active and CCR material is several feet thick, increasing in grade to the east. The south face of the landfill has been covered and vegetated for a short period of time and vegetation is thin, the soil is rocky and erosion rills are present on the slope.

The toe of the slope is flat and poorly drained and is bordered by a gravel access road to the south. The majority of active CCR material is being placed in the central portion of the landfill.

Associated Engineers, Inc. will be retained to assist in developing measures to address maintenance items (e.g. erosion, bare spots, drainage and seepage issues, invasive vegetation, animal burrows, etc.) identified in this inspection description.
