D.B. Wilson CCR Landfill

Disposal of Coal Combustion Residuals (CCR) from Electric Utilities Final Rule CCR Landfill 2017 Annual Inspection Report

January 11, 2018

Project ID: 170138C

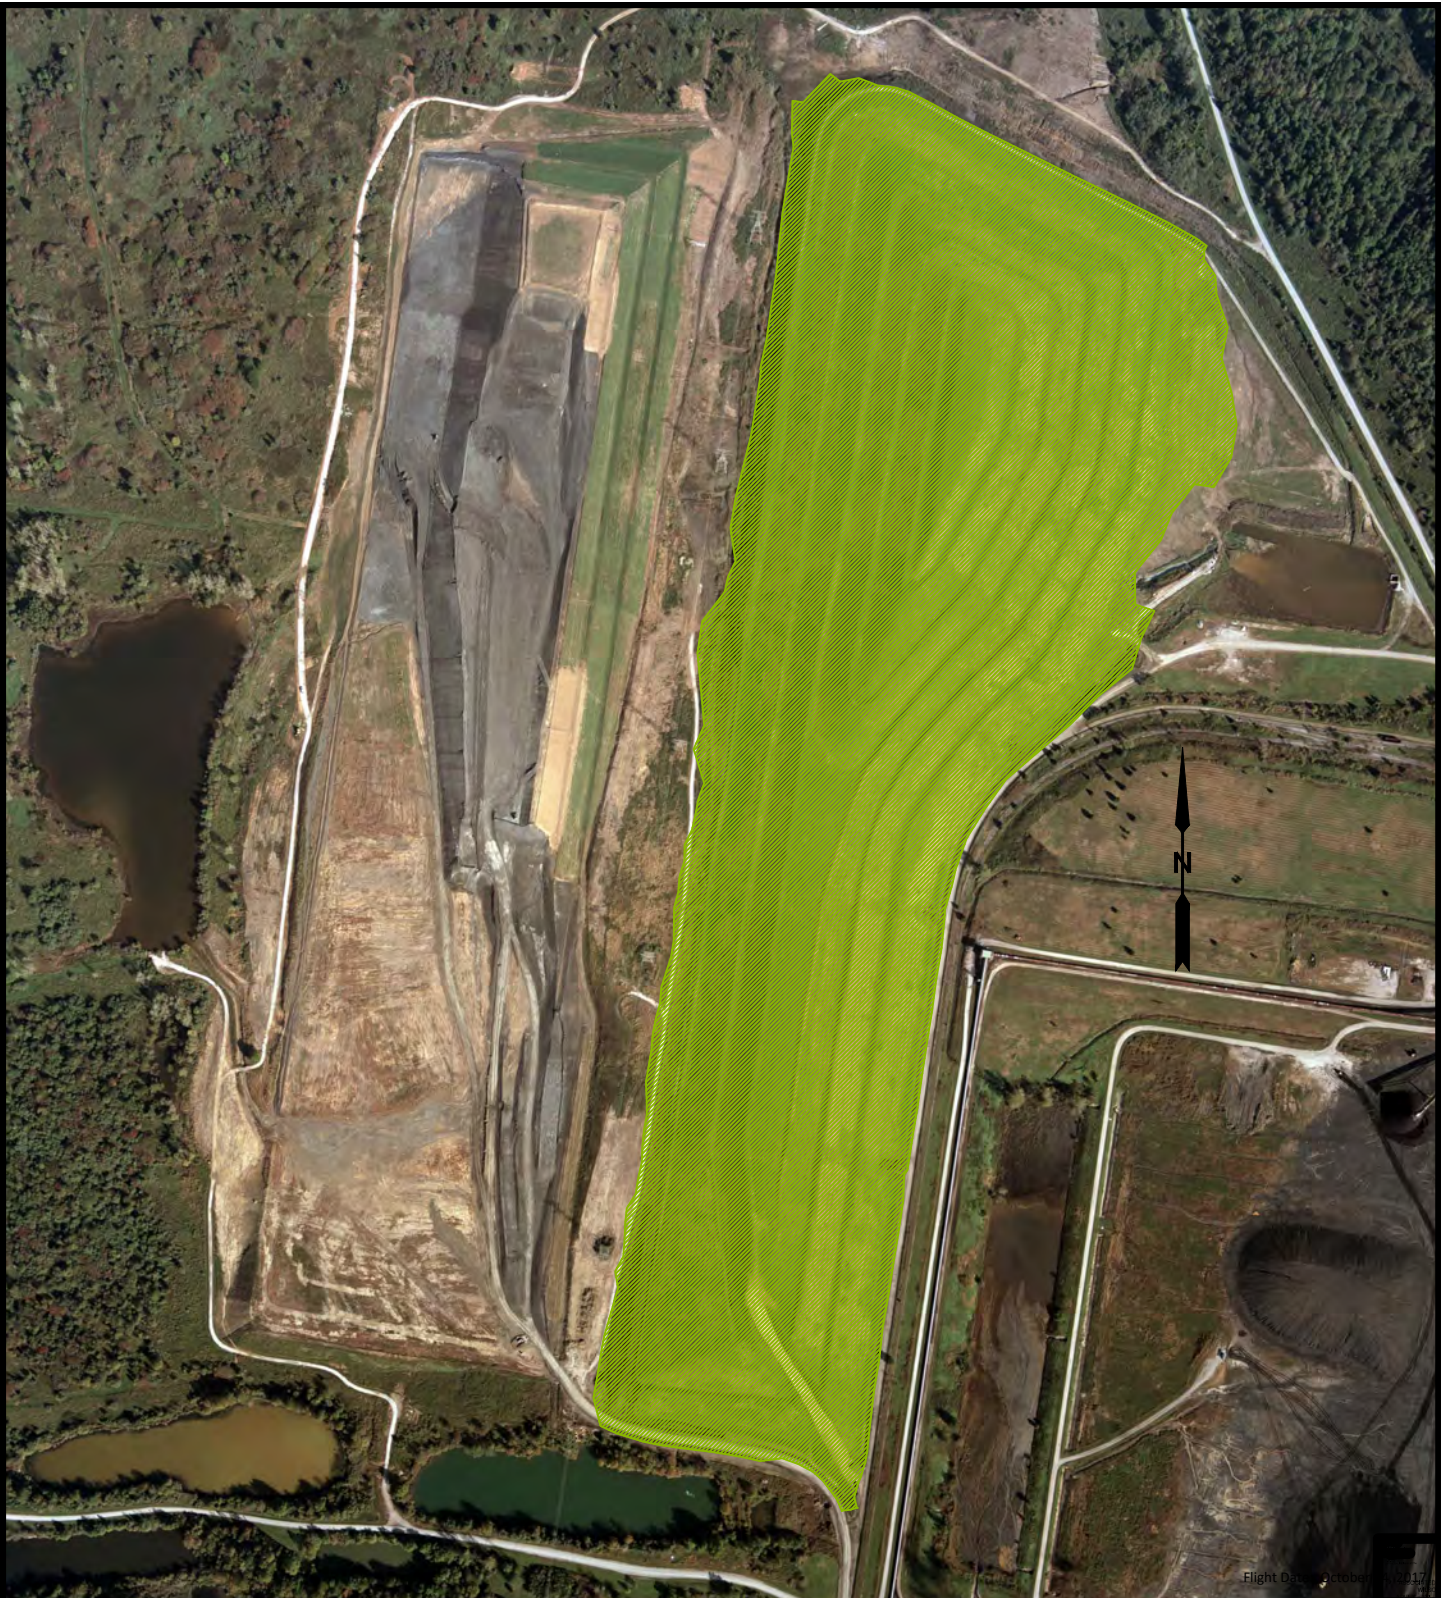
D.B. Wilson CCR Landfill
2017 Annual Inspection Aerial Photo

The inspection consisted of a visual assessment of the landfill and associated drainage control features; and began at the southeast end of the landfill along the lower slope, toe and runoff control ditch. Soil material was observed to be rocky and vegetation sparse on the slope. The runoff ditch slopes were eroded and not vegetated. The inspection continued along the lower slope which transitioned into the first bench which was not vegetated. Graded/uncovered CCR material comprised the slope above the first bench at this location. The graded/uncovered second slope continued north approximately 600 feet and transitioned into a covered/ vegetated section of the slope. Areas of the slope were sparsely vegetated, and deep ruts from equipment that appeared to have been stuck in a wet area was observed on the bench. The inspection continued north on the first bench where the runoff ditch below the first slope was observed to be unvegetated and eroded. A storm water drain inlet on the first bench approximately 350 feet north of the equipment ruts was observed to need repair. Vegetation on the first bench and second slope was generally good with areas of sparse vegetation. Vegetation on the second slope was observed to improve as the inspection proceeded to the northwest corner of the landfill.

The inspection proceeded from the northwest corner to the lower north slope which has been reworked to repair erosion and to blend into the graded/uncovered slope on the west side of the north slope. The side slopes of the runoff control ditch on the north side of the landfill were observed to be steep, eroded and unvegetated. The inspection proceeded to the first slope of the northeast side of the landfill where a large area of the slope was eroded and unvegetated. The inspection continued south along the interface of the east toe of the first slope and the runoff control ditch; cover material continued to be eroded and unvegetated. Inspection of the first slope and runoff control ditch proceeded south and several areas of seepage were observed along an interval from approximately 600 feet to 1100 feet south of the northeast corner of the landfill. Proceeding south, the runoff control ditch continued to be unvegetated to sparsely vegetated, eroded and contained sediment. The first slope was sparsely vegetated and equipment/mower tracks were visible. Approximately 1600 feet north of the southeast corner of the landfill, the first slope transitioned into the previously inspected uncovered first bench and second slope. At this point the inspection proceeded to the second bench of the east side of the landfill where the active area transitioned into the recently covered third slope which had apparently been seeded in the fall; vegetation was sparse and poorly developed. The third slope transitioned into previously covered and vegetated area that supported good vegetation which continued to the northeast corner of the landfill.

The inspection proceeded along the vegetated north slope and transition to the active disposal area, and then south along the east containment berm. The berm out-slope was very sparsely

vegetated and rills and minor gullies were observed along the length of the berm. The inspection proceeded to the interior of the containment berm where a large area of CCR material had been placed but was not currently being worked. This area comprises most of the southeast quadrant of the landfill. The south and east out-slopes below this area were observed to be eroded and poorly vegetated. The interior of the active landfill was inspected and appeared in good operating condition. Portions of an approximate one acre area at the northeast corner of the landfill top had been regraded to control drainage; vegetation was poorly developed. The majority of ongoing CCR material placement was visible on the central and west side of the landfill.
