Re: Coleman Station Ash Pond Inspections

Semi-Annual Impoundment Inspection
Coleman Station
Hancock County, Kentucky
December 5, 2024

Inactive Ash Pond A

Inactive Ash Pond C

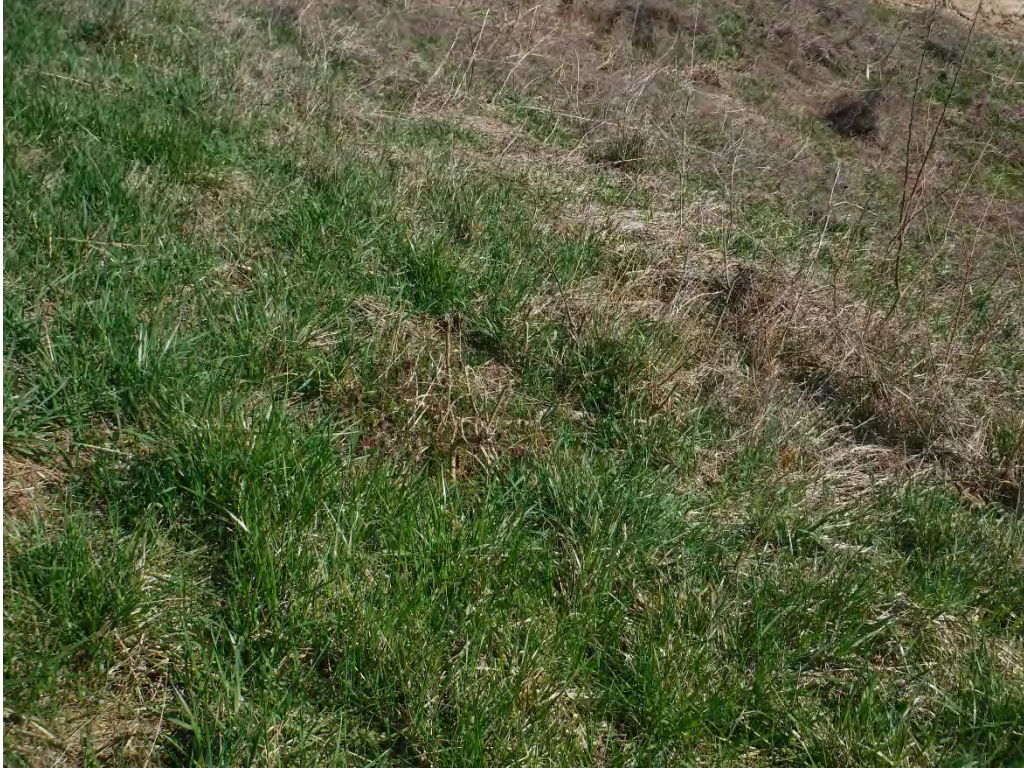
ITEM	STATUS			OBSERVATIONS	ACTION		
	YES	NO	N/A		Repair	Monitor	
3	DOWNSTREAM SLOPE & TOE						
	Any erosion	<input checked="" type="checkbox"/>	<input type="checkbox"/>	<input type="checkbox"/>	Indications of minor erosion at various locations.	<input type="checkbox"/>	<input checked="" type="checkbox"/>
	Longitudinal cracks	<input type="checkbox"/>	<input checked="" type="checkbox"/>	<input type="checkbox"/>		<input type="checkbox"/>	<input type="checkbox"/>
	Transverse cracks	<input type="checkbox"/>	<input checked="" type="checkbox"/>	<input type="checkbox"/>		<input type="checkbox"/>	<input type="checkbox"/>
	Adequate vegetative cover	<input checked="" type="checkbox"/>	<input type="checkbox"/>	<input type="checkbox"/>		<input type="checkbox"/>	<input type="checkbox"/>
	Are trees growing on the slope	<input type="checkbox"/>	<input checked="" type="checkbox"/>	<input type="checkbox"/>		<input type="checkbox"/>	<input type="checkbox"/>

3 – Erosion Downstream Slope

- Minor rutting due to mowers observed at numerous locations around the impoundment. Limit mowing activities when wet and monitor slopes for development of erosion.
- Isolated areas of minor erosion on downstream slopes. Monitor for worsening conditions.
- No immediate safety concerns observed.

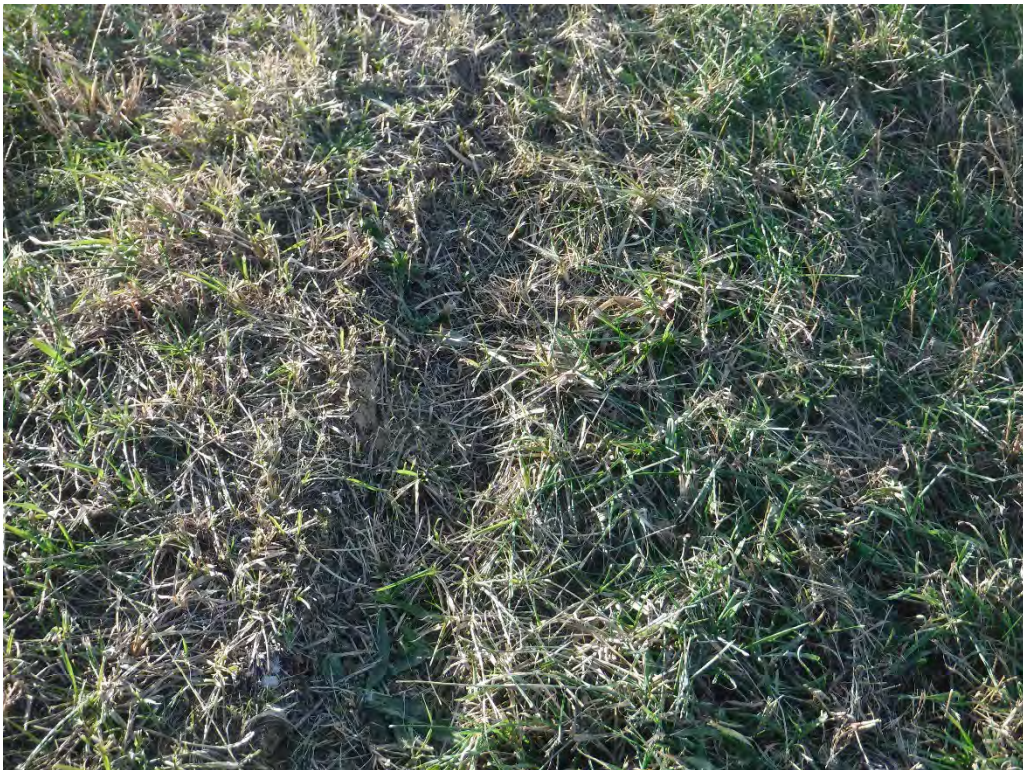
10 – Erosion Downstream Slope

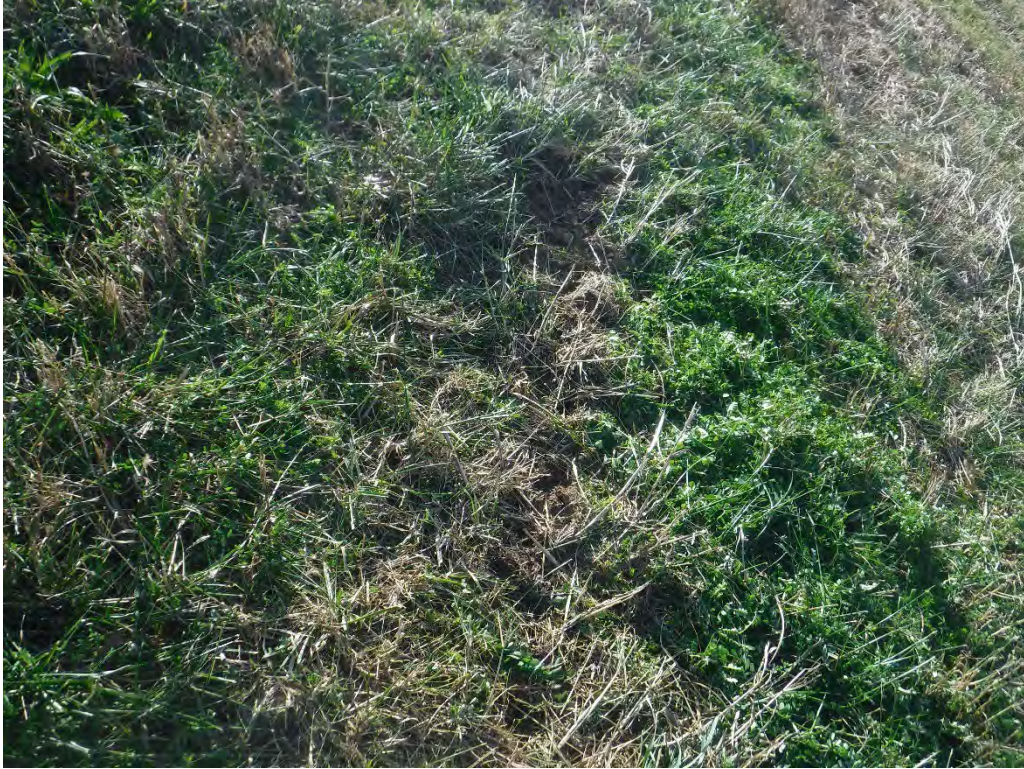
13 – Erosion Downstream Slope

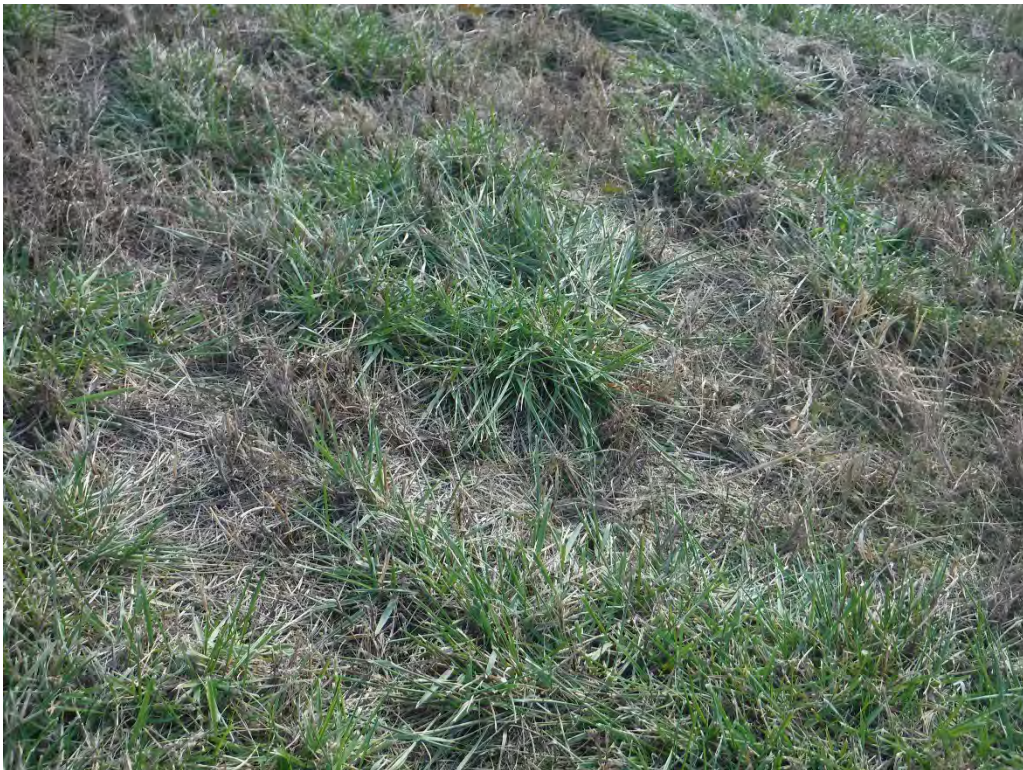
16 – Erosion Downstream Slope

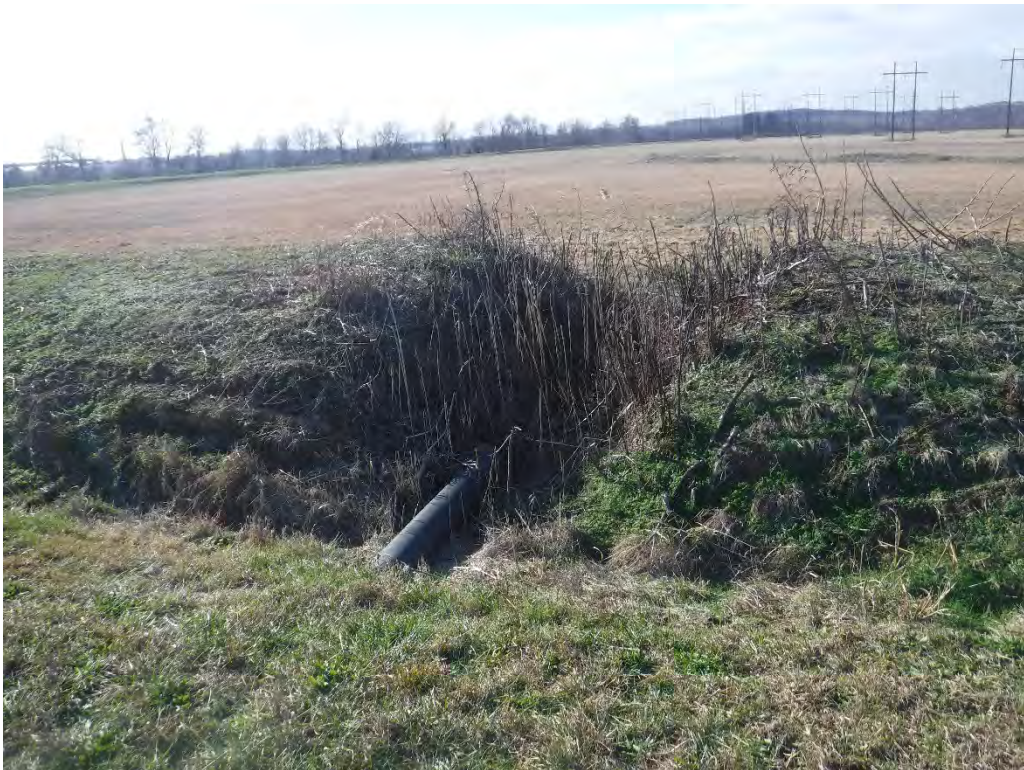
2 – Overgrown Area

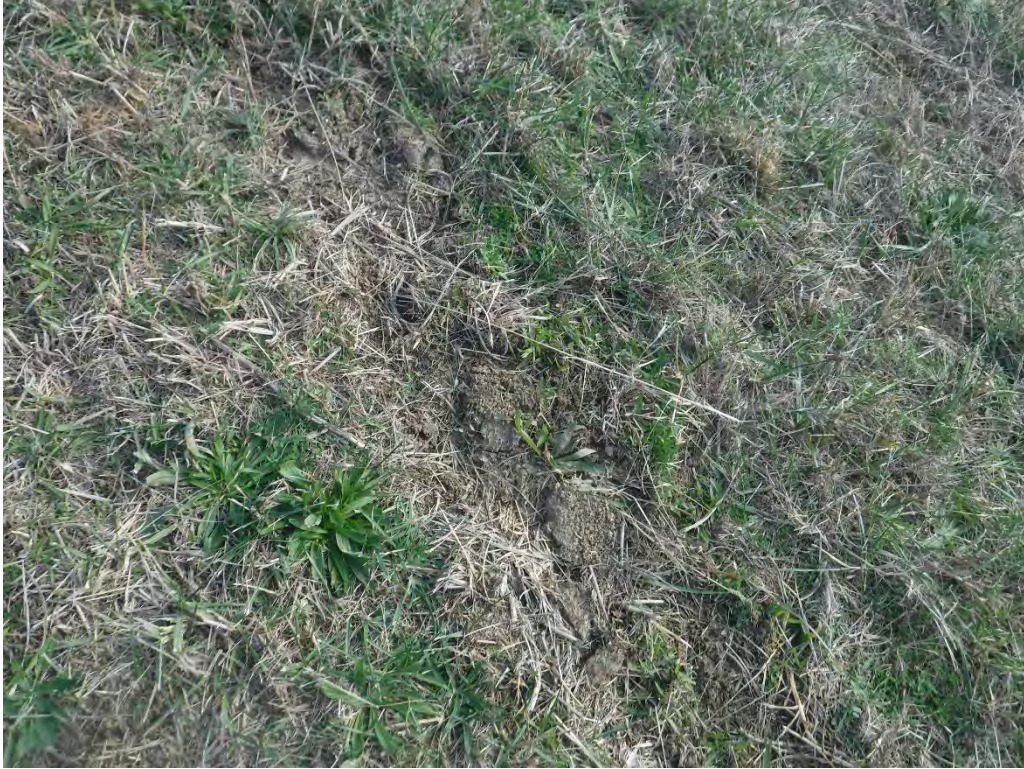
ITEM	STATUS			OBSERVATIONS	ACTION		
	YES	NO	N/A		Repair	Monitor	
3	DOWNSTREAM SLOPE & TOE						
	Any erosion	<input checked="" type="checkbox"/>	<input type="checkbox"/>	<input type="checkbox"/>	Isolated minor erosion at various locations.	<input type="checkbox"/>	<input checked="" type="checkbox"/>
	Longitudinal cracks	<input type="checkbox"/>	<input checked="" type="checkbox"/>	<input type="checkbox"/>		<input type="checkbox"/>	<input type="checkbox"/>
	Transverse cracks	<input type="checkbox"/>	<input checked="" type="checkbox"/>	<input type="checkbox"/>		<input type="checkbox"/>	<input type="checkbox"/>
	Adequate vegetative cover	<input checked="" type="checkbox"/>	<input type="checkbox"/>	<input type="checkbox"/>		<input type="checkbox"/>	<input type="checkbox"/>
	Are trees growing on the slope	<input type="checkbox"/>	<input checked="" type="checkbox"/>	<input type="checkbox"/>		<input type="checkbox"/>	<input type="checkbox"/>

3 – Erosion Downstream Slope

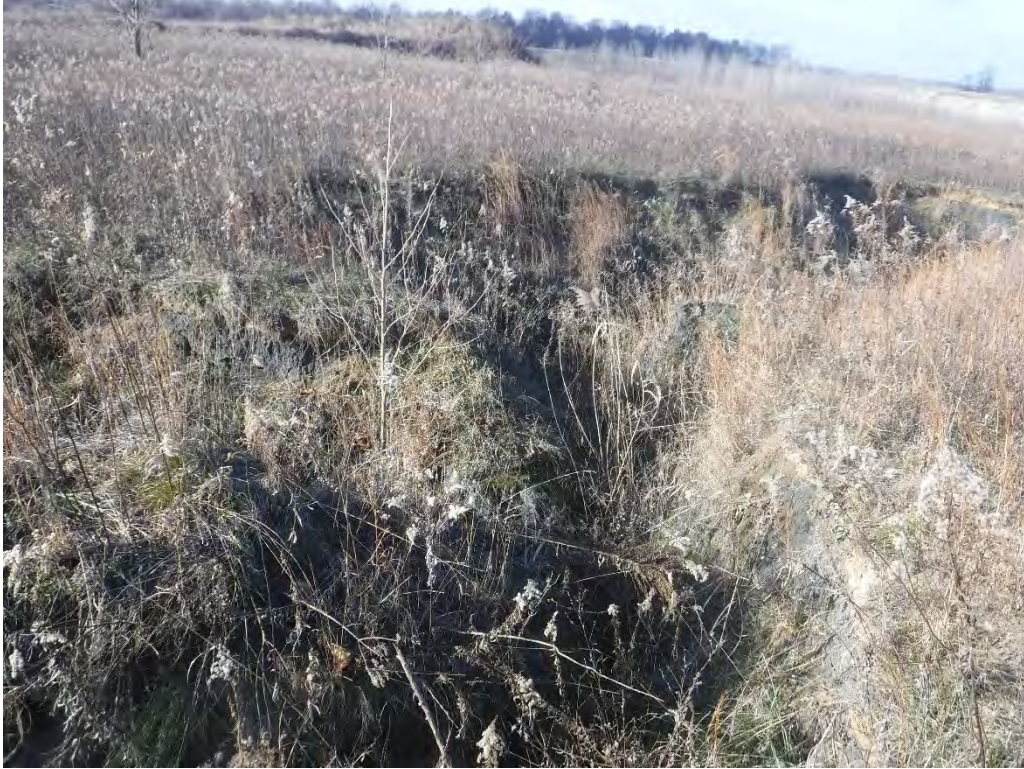
9 – Erosion @ Pond

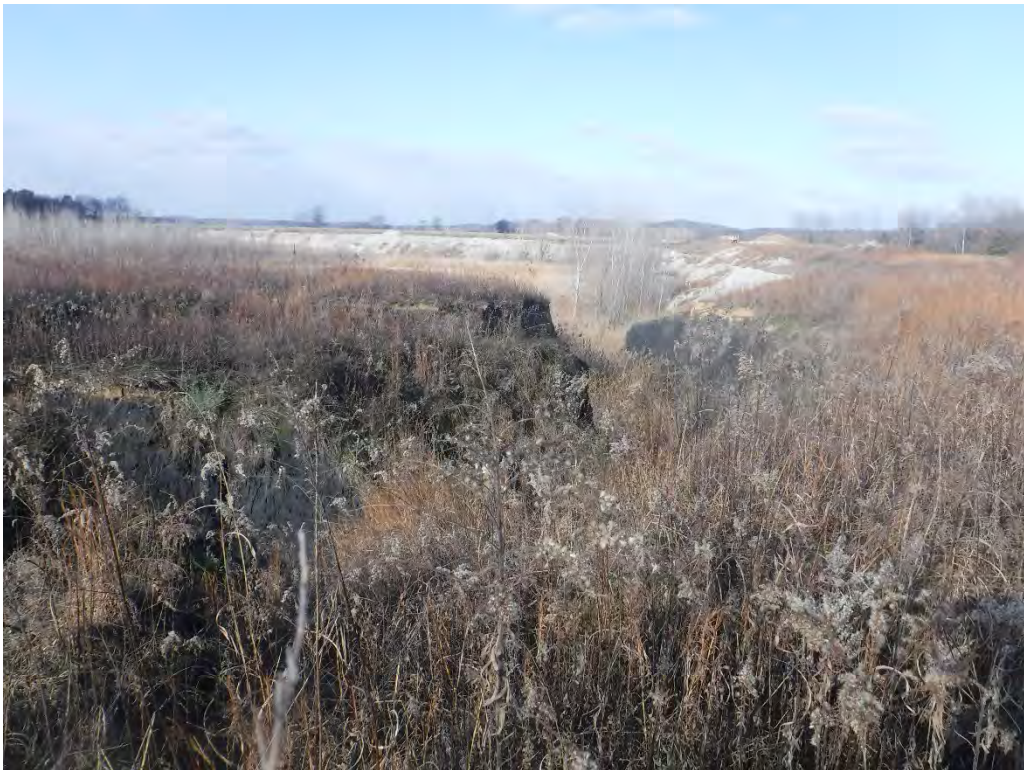
10 – Erosion @ Pond

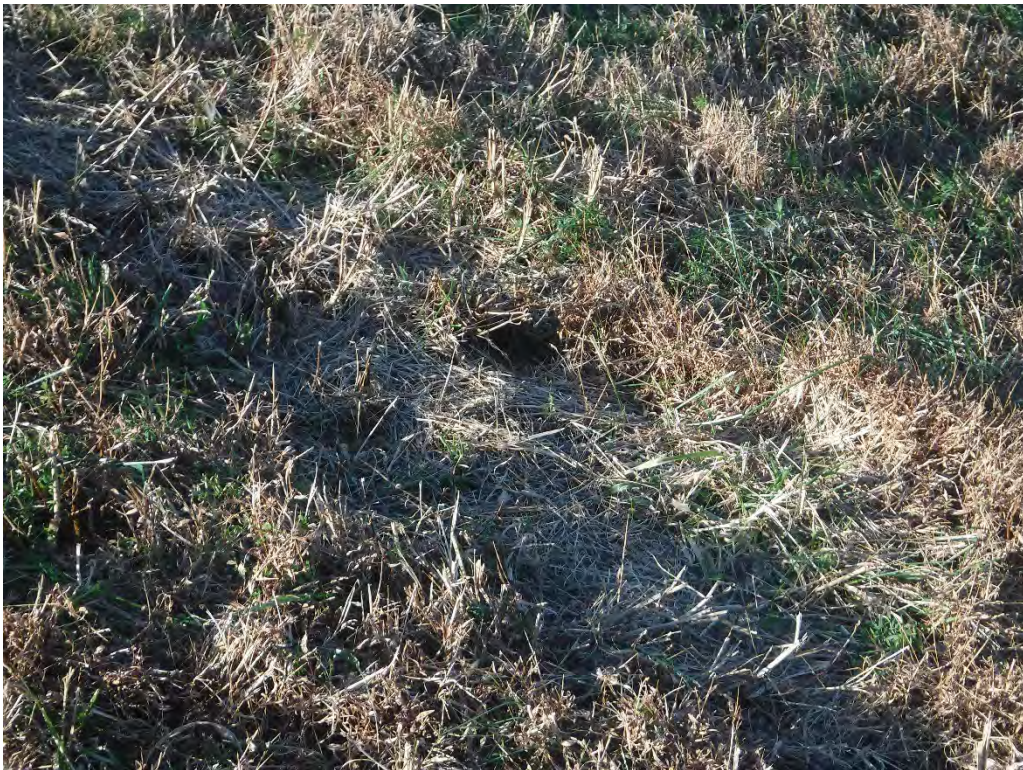
16 – Erosion Downstream Slope

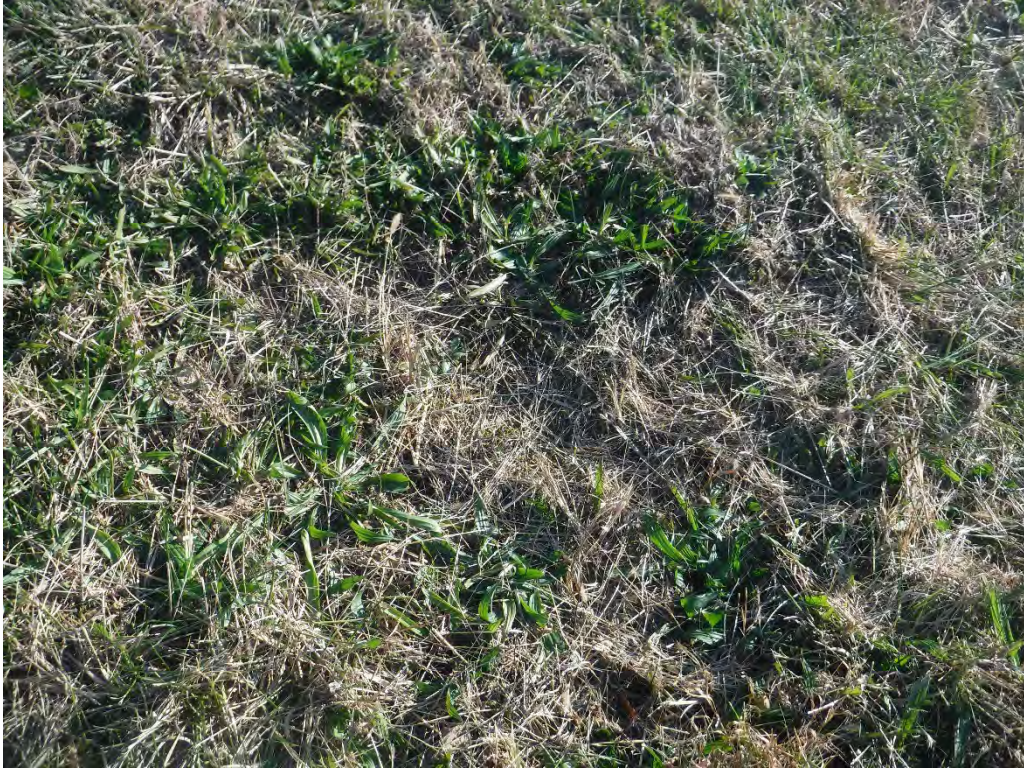
19 – Erosion Downstream Slope
