Green CCR Landfill

Disposal of Coal Combustion Residuals (CCR) from Electric Utilities Final Rule CCR Landfill 2025 Annual Inspection Report

December 30, 2025

Project ID: 25-0131

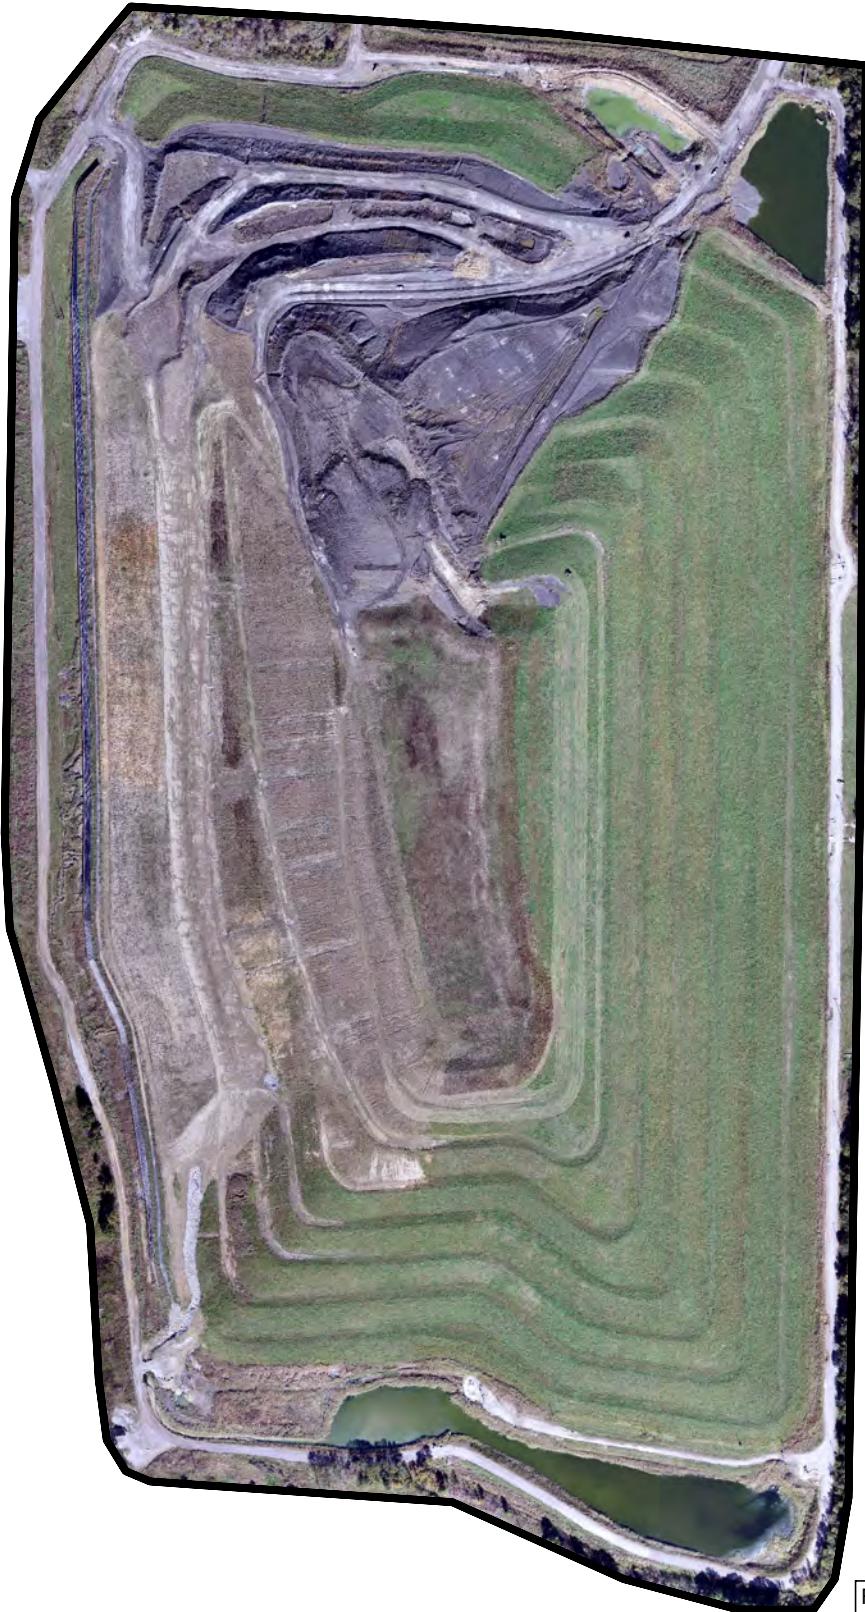
Sebree Station Green CCR Landfill
2025 Annual Inspection Aerial Photo

Flight Date: October 20, 2025
