D.B. Wilson Phase II CCR Landfill

**Disposal of Coal Combustion Residuals (CCR) from Electric Utilities Final Rule
CCR Landfill 2024 Annual Inspection Report**

December 30, 2024

Project ID: 24-0199

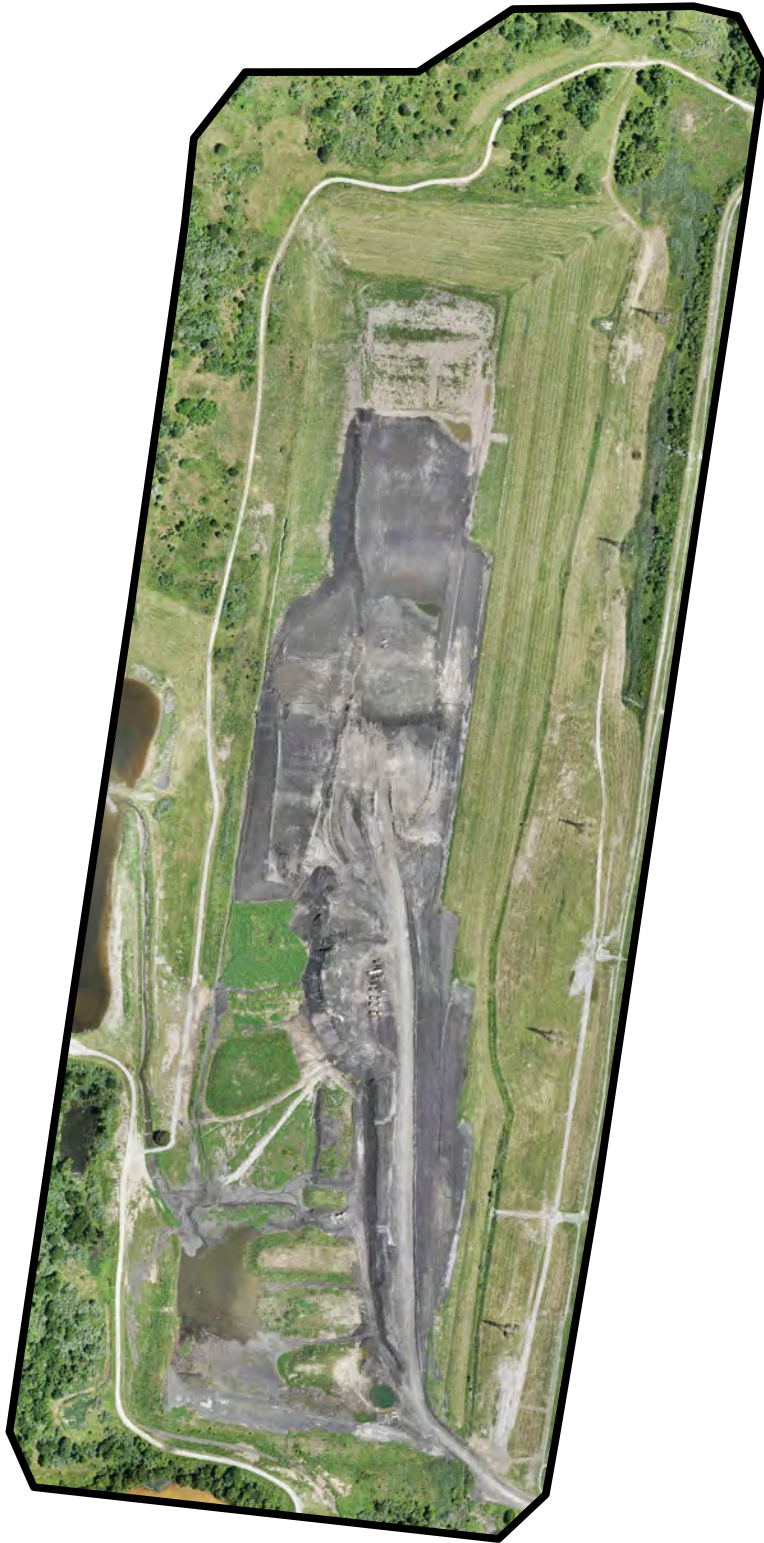
DB Wilson CCR Landfill
2024 Annual Inspection Aerial Photo

Flight Date: June 6th, 2024
