## **Reid/HMP&L CCR Surface Impoundment**

### **Disposal of Coal Combustion Residuals (CCR) from Electric Utilities Final Rule CCR Impoundment 2023 Annual Inspection Report**

**December 29, 2023**

**Project ID: 23-0166**

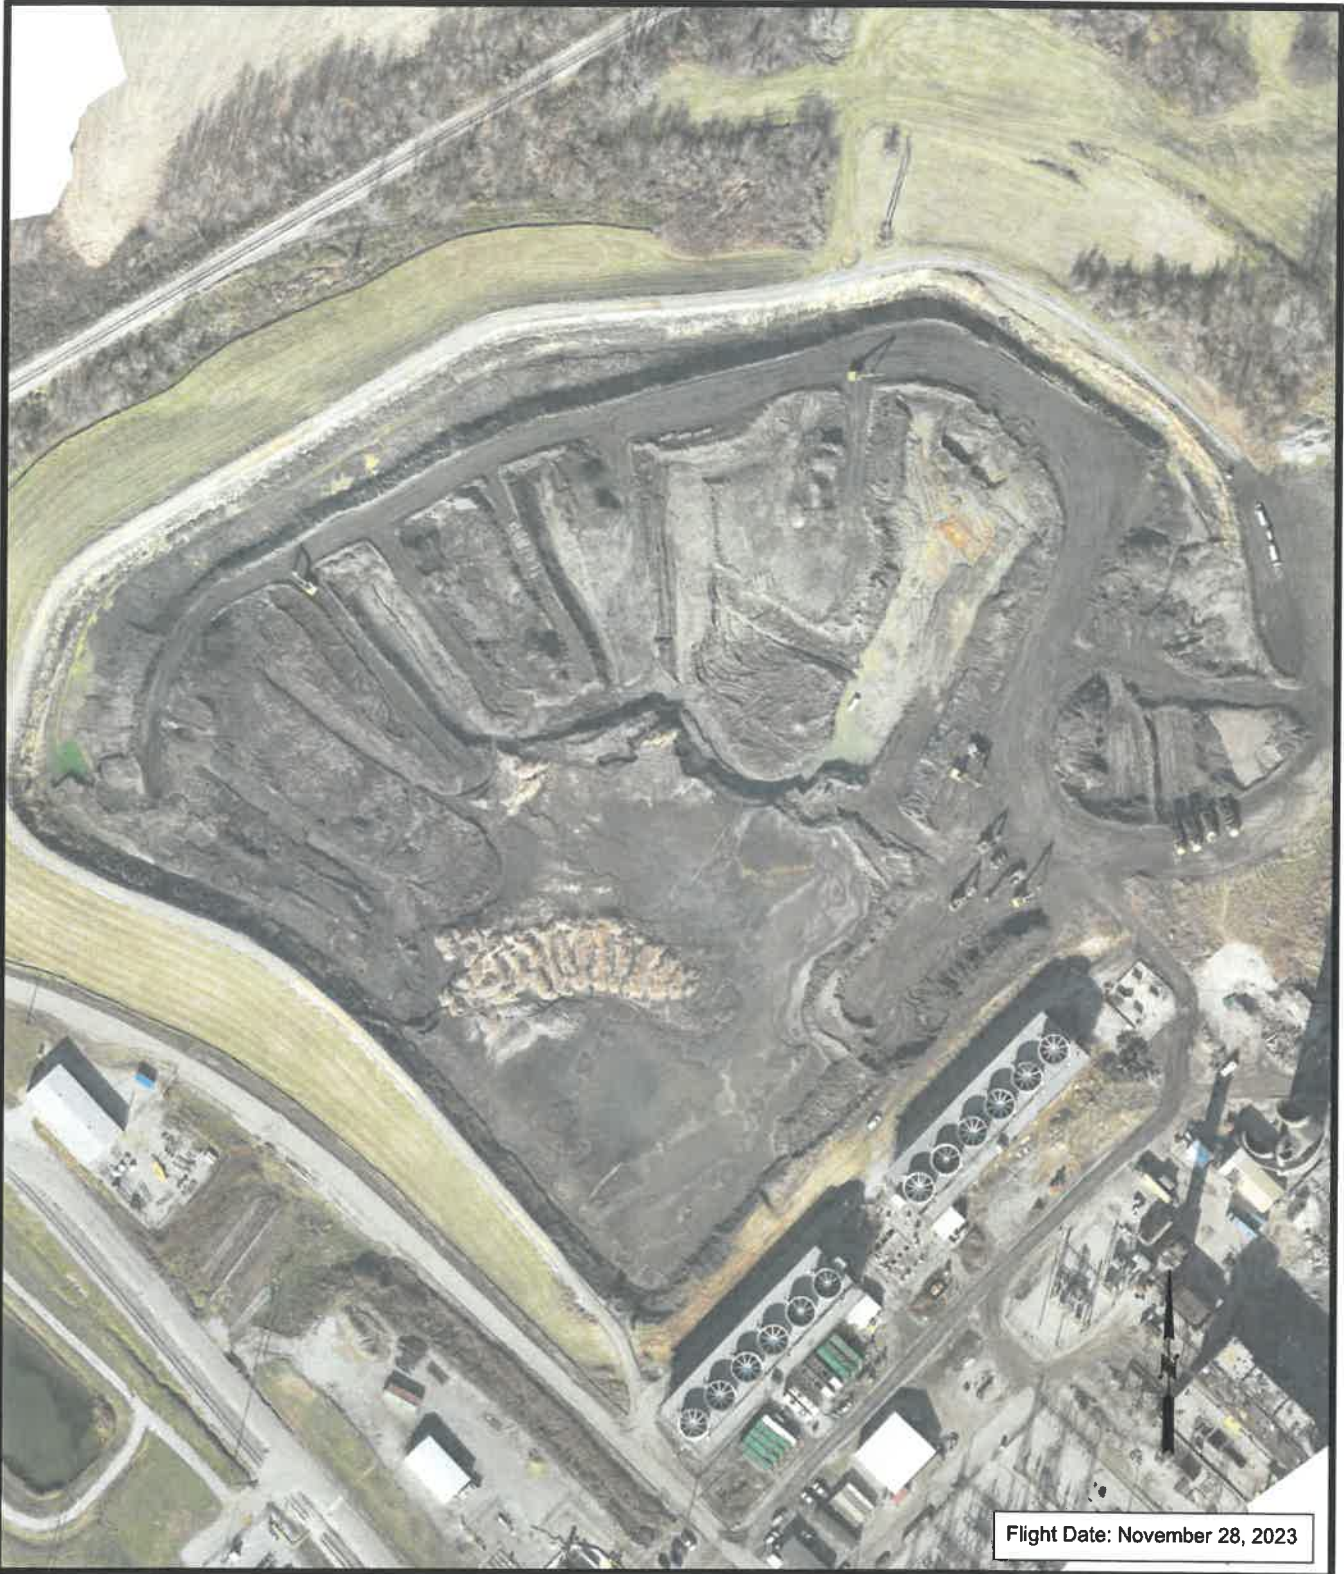
Reid/HMP&L CCR Surface Impoundment  
2023 Annual Inspection Aerial Photo

The inspection consisted of a visual assessment of the surface impoundment, embankments, and discharge; and began at the northeast corner of the impoundment adjacent to the access road located on the north embankment crest. The inspection revealed that the heavy vegetation noted previous years has been removed. The pond has been dewatered and is actively having CCR material removed from the impoundment and being placed in the onsite landfill. The pond closure activities have resulted in the excavation of CCR material around the perimeter of the dam resulting in no CCR or water being impounded against the dam . The inspection began at the southeast abutment near the discharge structure. The discharge structure was unobstructed and properly maintained. However, due to closure activities the discharge structure has been taken out of service. A pumping system is in place to maintain the dewatered condition of the pond. The water was being maintained approximately 16 feet below the dam crest. The access road continues around the impoundment on the crest of the west and north embankments and is adequately rocked and maintained for construction activities.

The inspection continued to the downstream slope of the south embankment. The south downstream slope was vegetated and generally in good condition. As the inspection progressed west, rutting from tracked equipment was present on the southwest corner of the downstream slope. Areas of saturated ground were observed on the lower slope adjacent to the toe were observed. Signs requiring hand mowing of these area were noted and few if any mower ruts were present in these areas. Minor mower damage was observed along the upper downstream slope at the north end of the west embankment as well as the north end of the north embankment. This does not require and corrective action. The crest of the west embankment was well maintained.

The inspection of the downstream slope of the north embankment noted an area of approximately one-third acre of standing water and very thick vegetation at the east end of the embankment. The crest of the north embankment was in good condition. The surface impoundment no longer receives coal combustion residual (CCR) flow as of February 1,

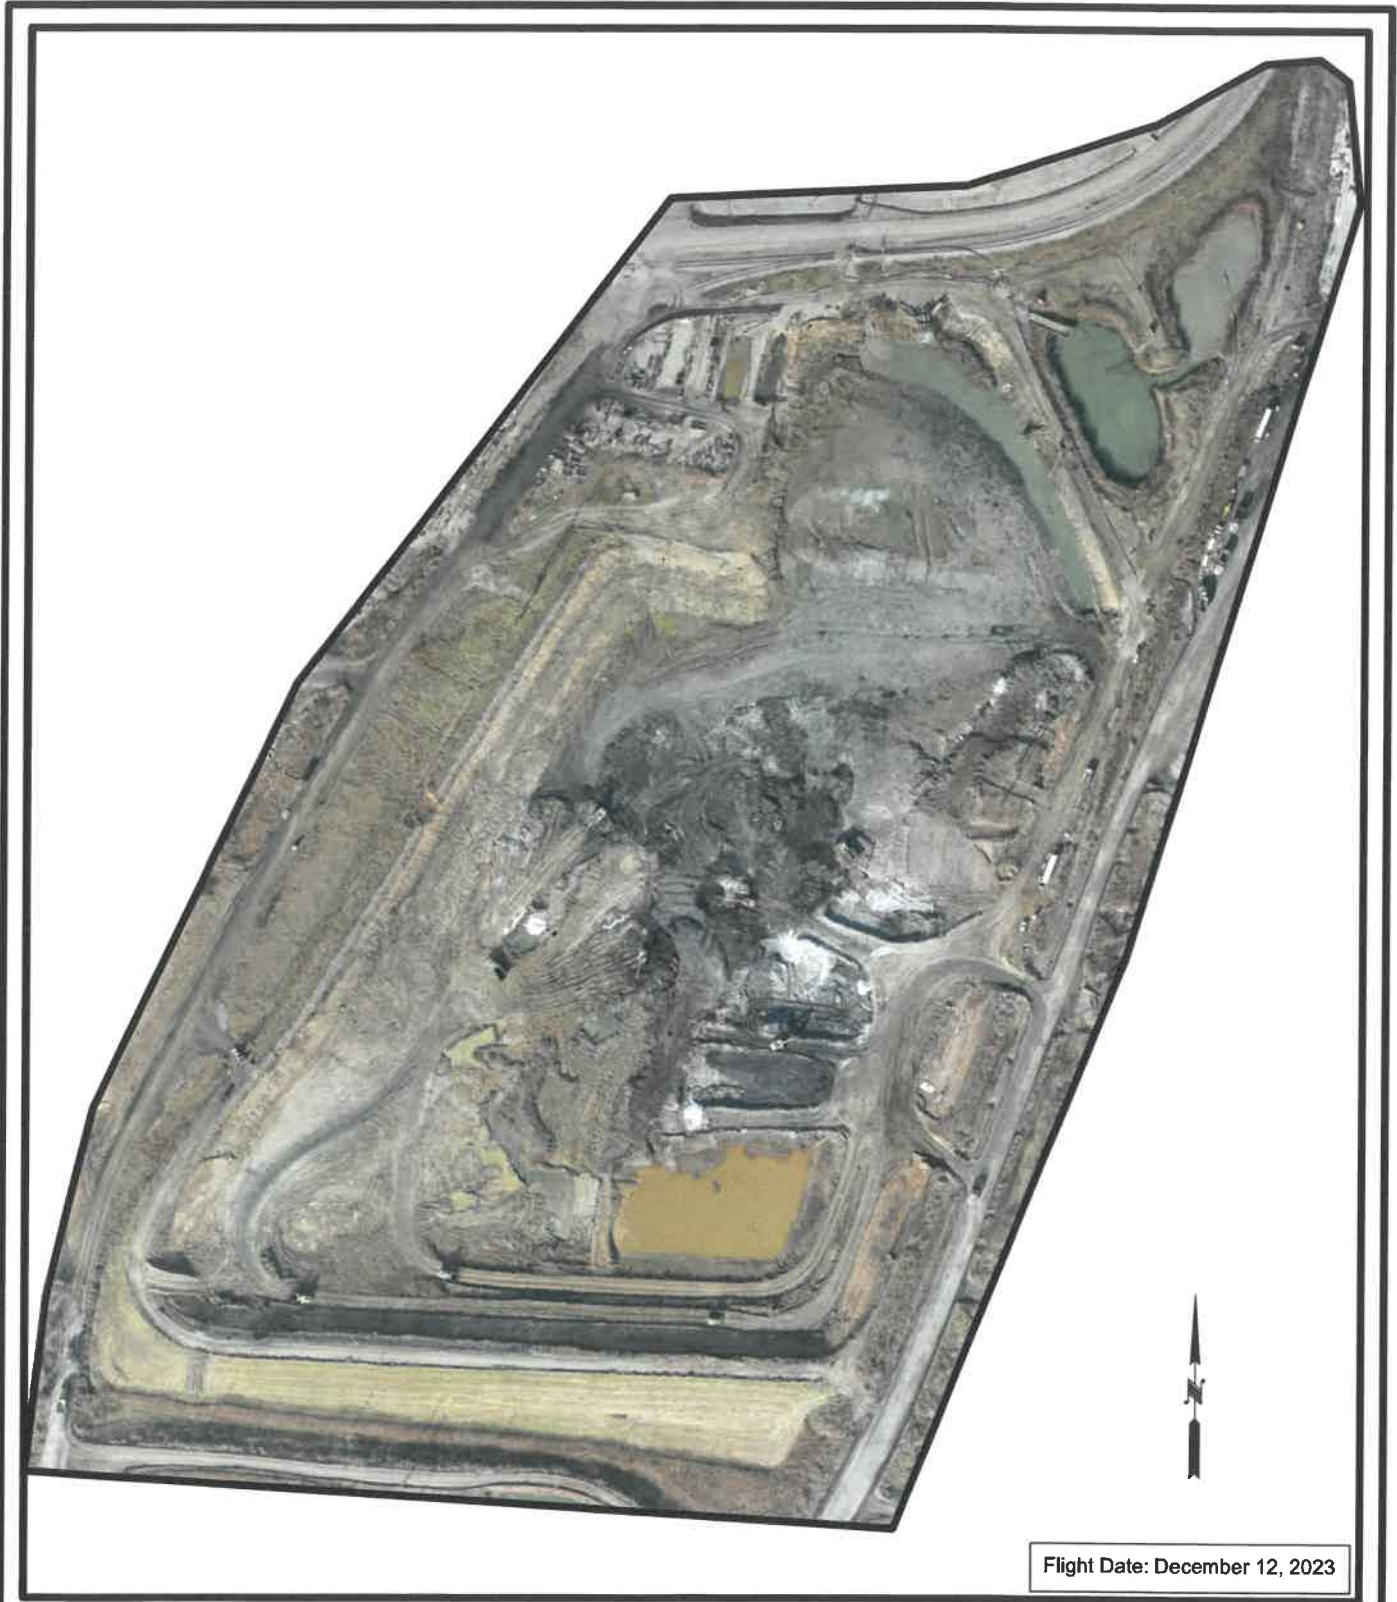
Green CCR Surface Impoundment  
2023 Annual Inspection Aerial Photo

It should be noted that a contractor is currently on-site executing implementation of the closure plan for this facility. The pond has been dewatered and excavated to the extent that the spillway is no longer functional, and the dam no longer impounds water or CCR. The inspection consisted of a visual assessment of the surface impoundment, embankments and out of service discharge; and began at the southwest corner of the impoundment on the embankment crest access road. The crest access road is adequately rocked and maintained. The upstream embankment slope was bare due to ongoing closure activities. The downstream slope at the southwest corner of the impoundment had areas that are sparsely vegetated. Thick vegetation adjacent to the discharge pipe outlets (no longer operational at the time of inspection) covered the ground in this area. Additionally, minor erosion and mower wheel tracking was present along the downstream slope. Otherwise, the south embankment downstream slope was generally well vegetated and mowed. Limited small animal burrows were observed on the mid-slope and lower downstream slope of the central portion and east end of the south embankment. Moderate erosion was observed along the access roadway along the southeast groin of the downstream embankment slope. There was fresh disturbance in this area related to the construction activity currently under way at the site. Dense vegetation along the ditch located adjacent to the south embankment toe that directs drainage east towards the Green River had been mowed and no water was present at the time of the inspection.

The east side of the impoundment interior contains dewatered CCR material at or above the pool elevation. This area is currently utilized to stage construction activities. Active management of CCR material was observed where stored above the pool elevation. The east crest access road is not well separated from interior CCR storage areas. Areas of exposed CCR material and minor erosion were observed on the east embankment downstream slope. At the time of the inspection the contractor was actively removing CCR from the pond to facilitate closure activities.

The west embankment crest and upstream slope was generally observed to be disturbed by the closure activities. CCR material has been removed down to the original soil in this area. Moderate erosion and equipment tracking were observed throughout the impoundment. This was related to the active closure operation that was under way. This activity does not pose a stability issue with the structure.
